**Bay Area Toll Authority  
Oversight Committee**

**(i) Richmond-San Rafael (RSR) Bridge Pilot Project Recommendations**

**(ii) Contract Amendment – RSR Bridge Access Improvement Project – On-Call Design Services: HNTB Corporation (\$100,000)**

6-3PARTNERS FOR ADVANCED TRANSPORTATION TECHNOLOGY  
INSTITUTE OF TRANSPORTATION STUDIES  
UNIVERSITY OF CALIFORNIA, BERKELEY

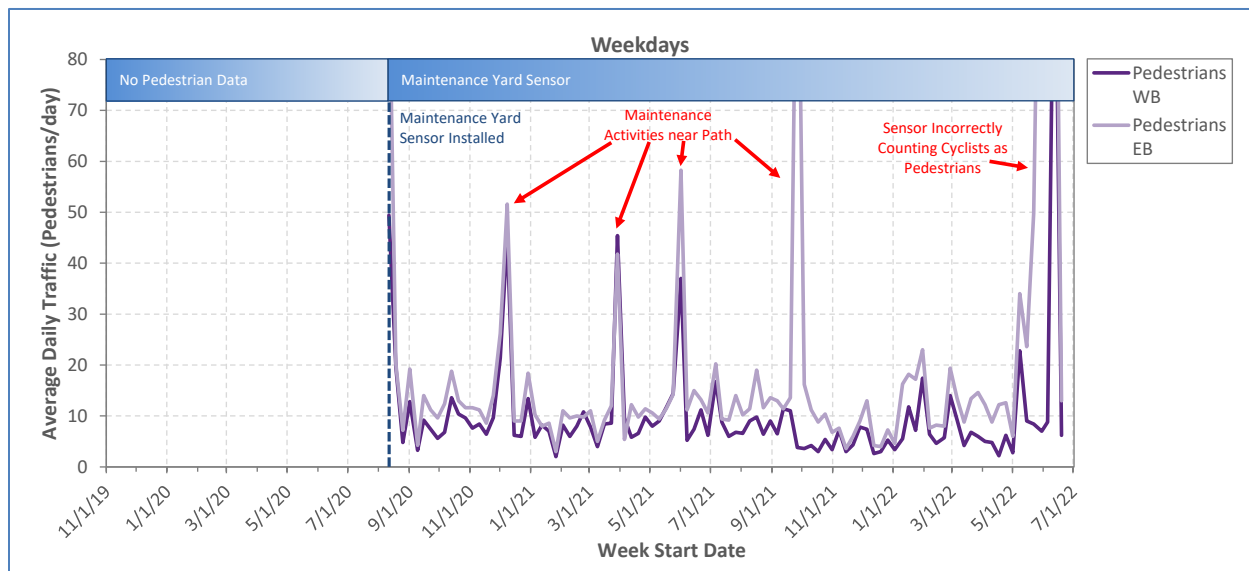
**Figure 7-1: Daily Pedestrian Traffic – Richmond Bridge – Weekdays, 2020-2022**

While pedestrian data were collected from both the initial Richmond and San Rafael sensors between November 2019 and Mid-August 2020, the counts that were returned during this period were unrealistically high, often in the thousands of pedestrians per day. This problem was attributed to placements that caused both sensors to capture some vehicles passing in the nearby traffic lane. The pedestrian counting capability was disabled at both stations in March 2021, leaving only data collected by the Maintenance Yard station from August 2020 onward.
